REPORT NOS. 208-TRC-91-003
212-TRC-91-003
301-TRC-91-003

VEHICLE SAFETY COMPLIANCE TESTING
FOR OCCUPANT CRASH PROTECTION,
WINDSHIELD MOUNTING, WINDSHIELD ZONE
INTRUSION, AND FUEL SYSTEM INTEGRITY

1991 BMW 318is

NHTSA NO. CM0503

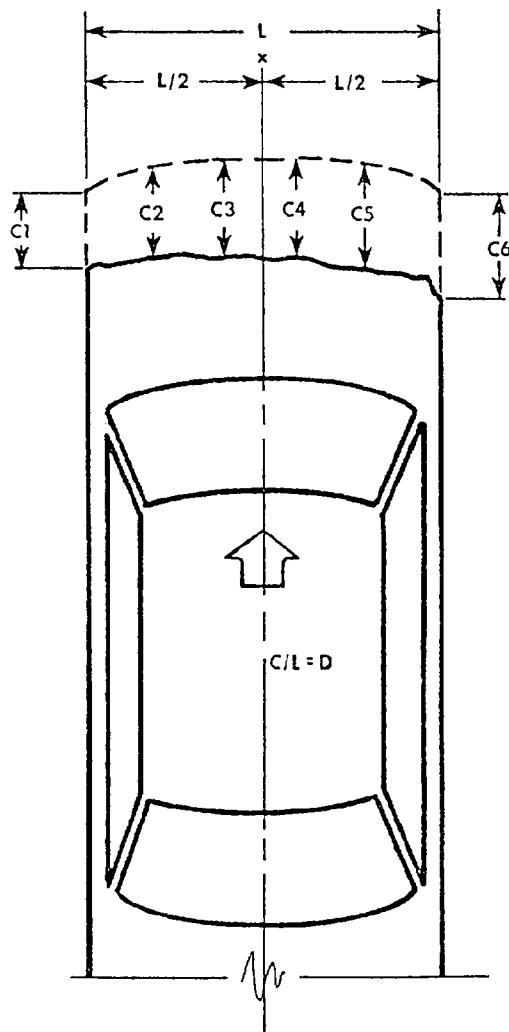
FIGURE 2 ACCIDENT INVESTIGATION DIVISION DATA
FOR 30 MPH FRONTAL BARRIER IMPACT

COLLISION DEFORMATION
CLASSIFICATION (CDC) CODE: 12FDEW3

CRUSH DEPTH
MEASUREMENTS:

C1 = 15.3 INCHES

C2 = 16.2 INCHES

C3 = 16.7 INCHES

C4 = 17.0 INCHES

C5 = 16.5 INCHES

C6 = 15.3 INCHES

L = 58.0 INCHES

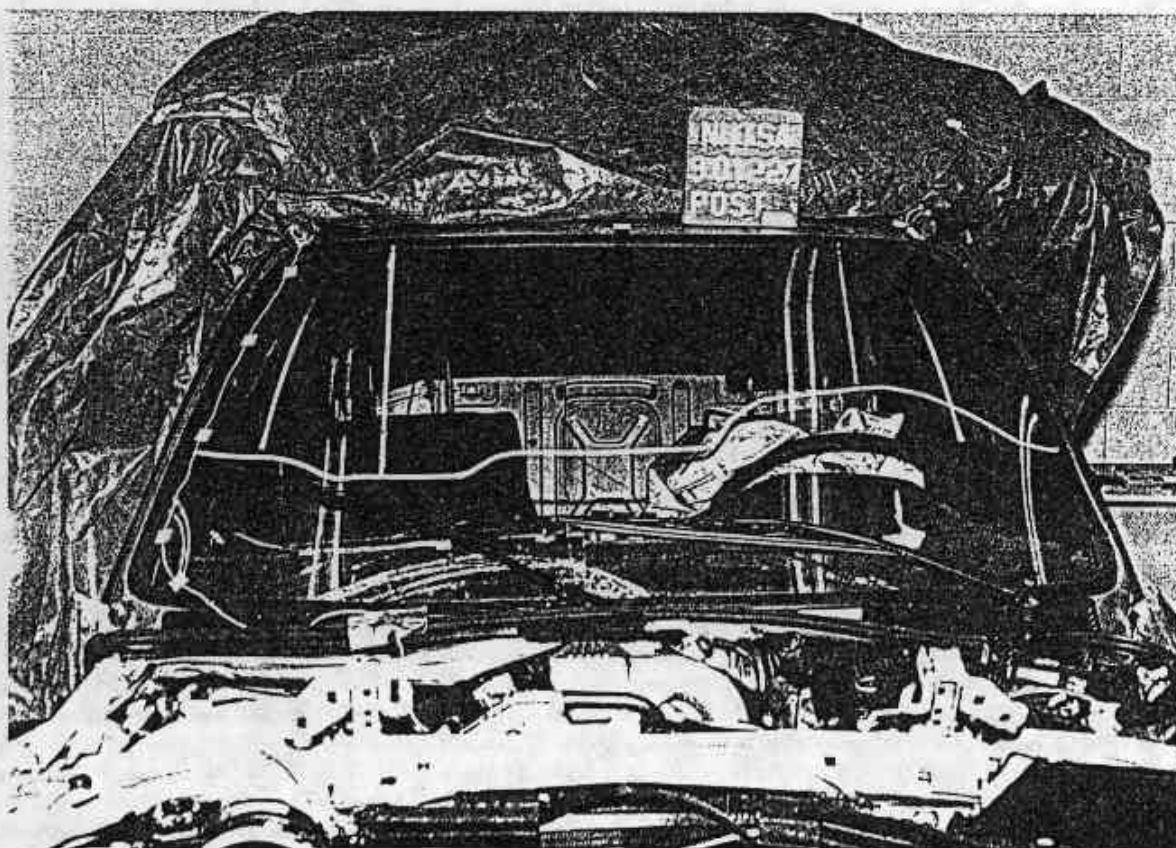
Figure A-14. POST-TEST WINDSHIELD VIEW

The right portion of the windshield was cracked upon impact.
